TECHNICAL REPORT S-76-10

# EVALUATION OF PARAMETERS AFFECTING HORIZONTAL STABILITY OF LANDING MATS

Yu T. Chou, Walter R. Barker, William P. Dawkins

Soils and Pavements Laboratory  
U. S. Army Engineer Waterways Experiment Station  
P. O. Box 631, Vicksburg, Miss. 39180

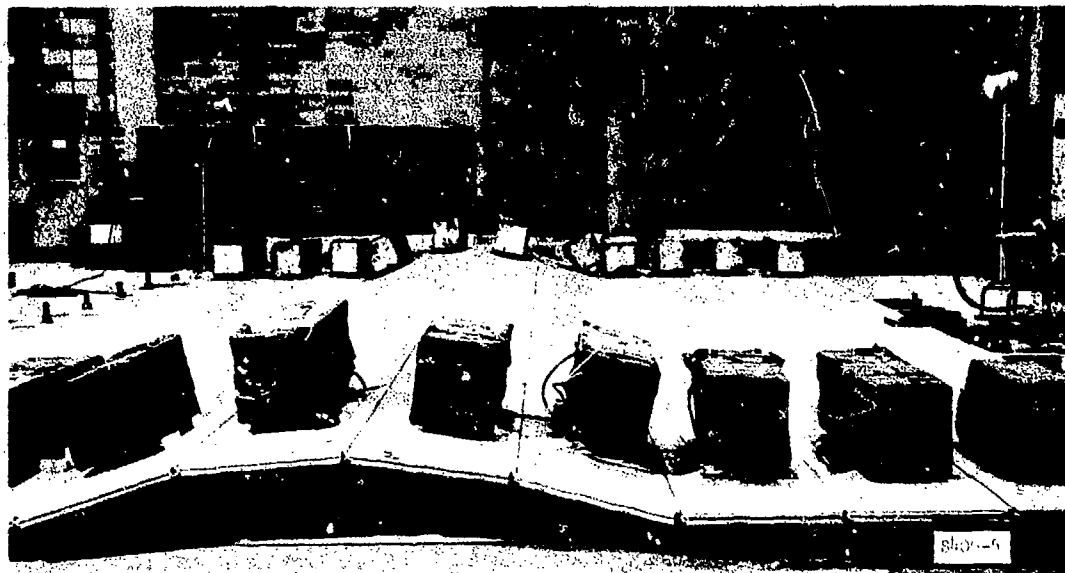
*Figure 4. Mat formation with concrete blocks during buckling*

was approximately 2000 lb each and that of a concrete block approximately 450 lb; therefore, the concrete block more loosely approximated the weight of the extra width of mat.

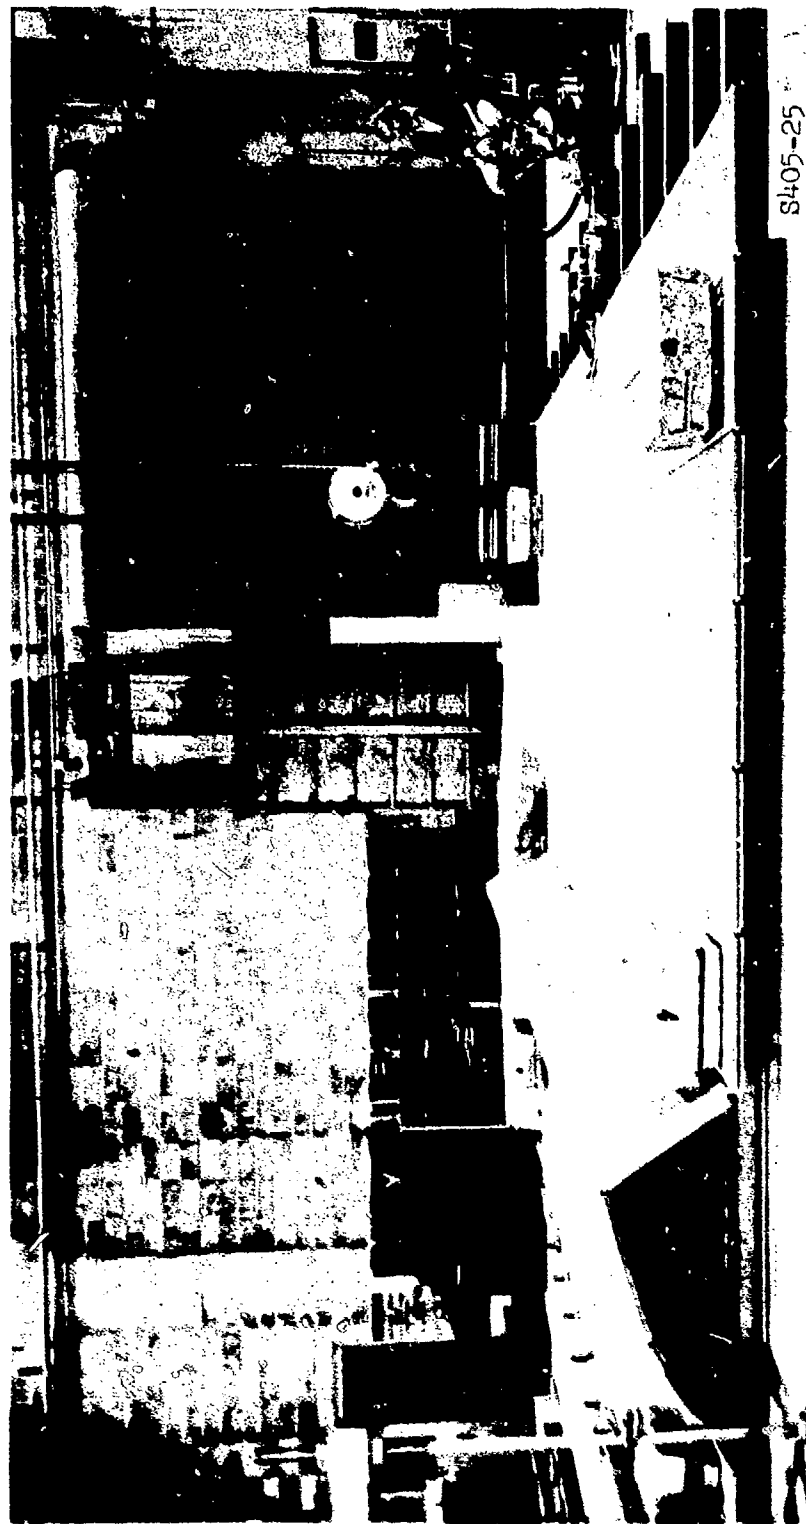
Figure 22 Buckled surface of XM18 mats, failure of joints incipient, 36 ft wide

concrete blocks. Figure 22 shows the buckled surface when failure of the joints was incipient. Figure 23 shows closeup views of failed joints. For other tests conducted in this study, the buckling process was discontinued long before failure became incipient.

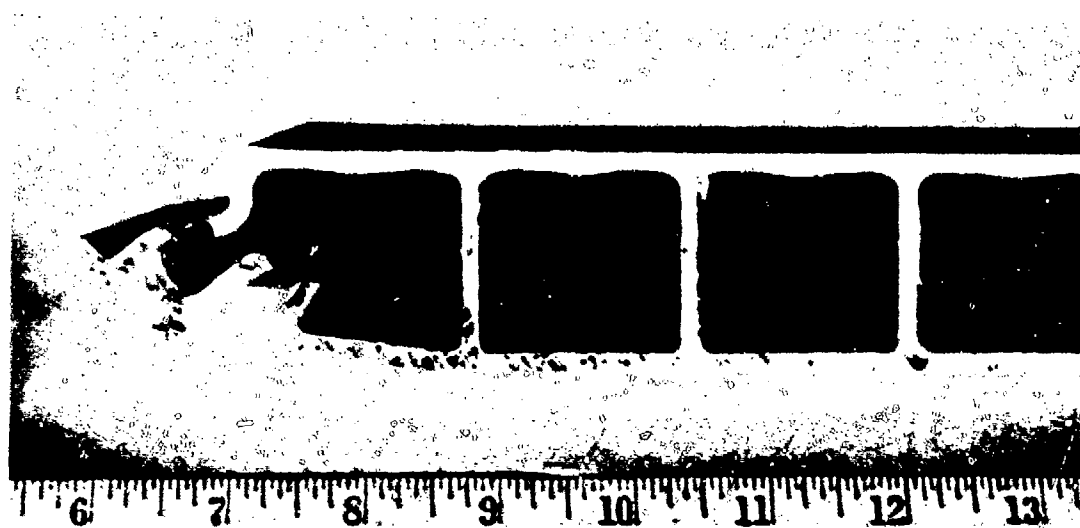
Figure A10. Cross section of mat showing mat failure from buckling

b. The failure of the male rail caused the joint failure. The first failure was in the top skin of the male rail; then the lower skin failed.
